# Uniform Mitigation Verification Inspection Form

| Inspection Date: Feb 27, 2026 | | |
| Owner Name: New Colonial House/ Marina Breeze Condominiums | | Contact Person: |
| Address: 500 S Beach St Building #2 F,G,H | | Home Phone: |

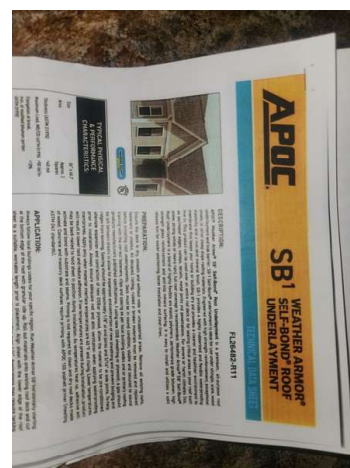
- ☒ A. SWR (also called Sealed Roof Deck) Self-adhering polymer modified-bitumen roofing underlayment applied directly to the sheathing or foam adhesive SWR barrier (not foamed-on insulation) applied as a supplemental means to protect the dwelling from water intrusion in the event of roof covering loss.
- ☐ B. No SWR.
- ☐ C. Unknown or undetermined.

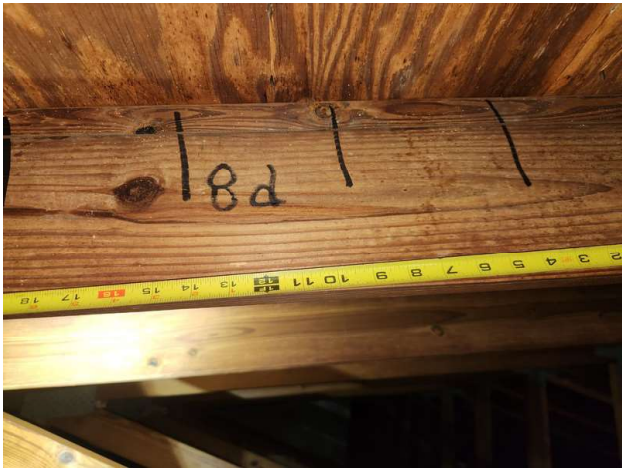
SPACING

- ☒ C. Plywood/OSB roof sheathing with a minimum thickness of 7/16" inch attached to the roof truss/rafter (spaced a maximum of 24" inches o.c.) by 8d common nails spaced a maximum of 6" inches in the field. -OR- Dimensional lumber/Tongue & Groove decking with a minimum of 2 nails per board (or 1 nail per board if each board is equal to or less than 6 inches in width). -OR-

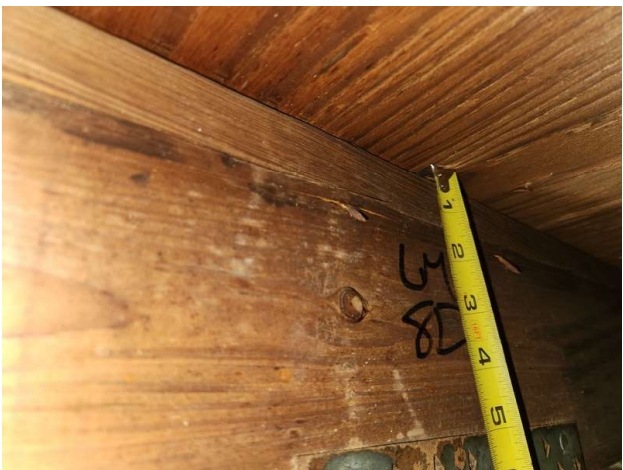
NAILS

- ☒ A. Toe Nails
  - ☒ Truss/rafter anchored to top plate of wall using nails driven at an angle through the truss/rafter and attached to the top plate of the wall, or
  - ☐ Metal connectors that do not meet the minimal conditions or requirements of B, C, or D
