# Uniform Mitigation Verification Inspection Form

| Owner Name: New Colonial House/ Marina Breeze Condominiums | | Contact Person: |
| Address: 500 S Beach St Building #3 I,J,K | | Home Phone: |

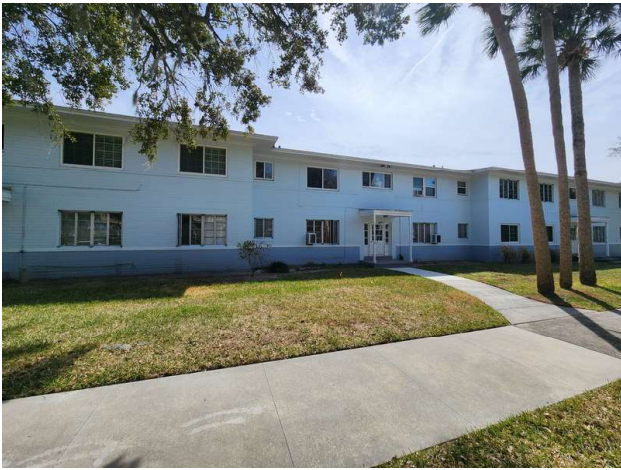
FRONT

- ☒ A. Hip Roof Hip roof with no other roof shapes greater than 10% of the total roof system perimeter.  
Total length of non-hip features: 0 feet; Total roof system perimeter: \_\_\_\_\_ feet
- ☐ B. Flat Roof Roof on a building with 5 or more units where at least 90% of the main roof area has a roof slope of less than 2:12. Roof area with slope less than 2:12 \_\_\_\_\_ sq ft; Total roof area \_\_\_\_\_ sq ft
- ☐ C. Other Roof Any roof that does not qualify as either (A) or (B) above.

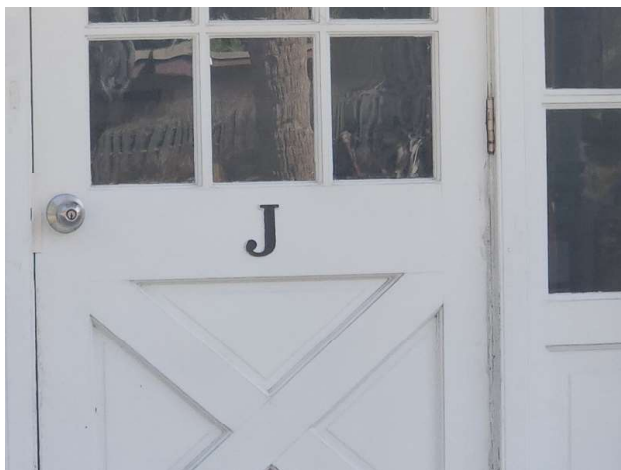
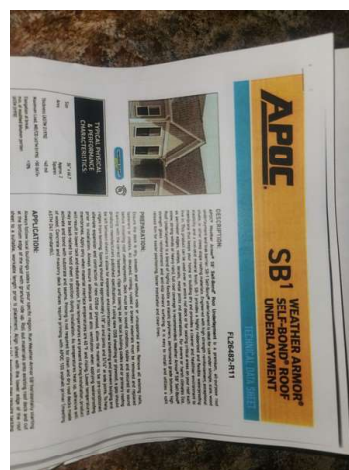
- ☒ A. SWR (also called Sealed Roof Deck) Self-adhering polymer modified-bitumen roofing underlayment applied directly to the sheathing or foam adhesive SWR barrier (not foamed-on insulation) applied as a supplemental means to protect the dwelling from water intrusion in the event of roof covering loss.
- ☐ B. No SWR.
- ☐ C. Unknown or undetermined.

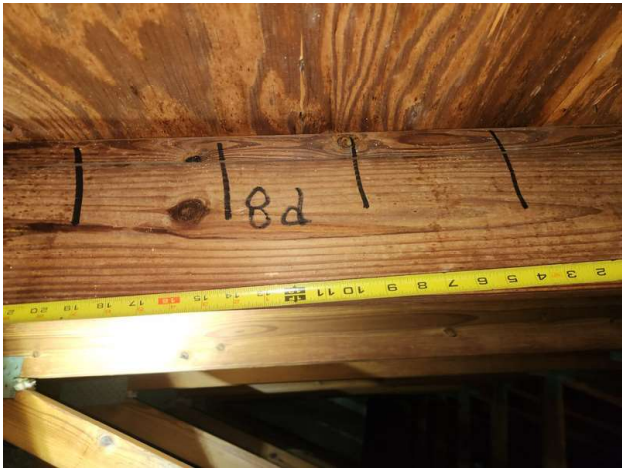
SPACING

- ☒ C. Plywood/OSB roof sheathing with a minimum thickness of 7/16" inch attached to the roof truss/rafter (spaced a maximum of 24" inches o.c.) by 8d common nails spaced a maximum of 6" inches in the field. -OR- Dimensional lumber/Tongue & Groove decking with a minimum of 2 nails per board (or 1 nail per board if each board is equal to or less than 6 inches in width). -OR-

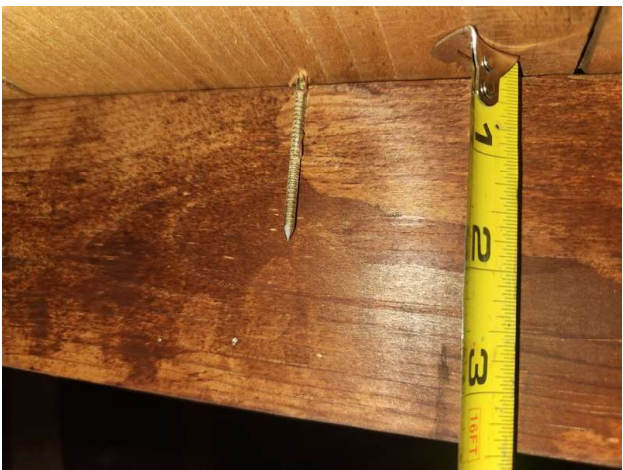
NAILS

Any system of screws, nails, adhesives, other deck fastening system or truss/rafter spacing that is shown to have an equivalent or greater resistance than 8d common nails spaced a maximum of 6 inches in the field or has a mean uplift resistance of at least 182 psf.
